DRAFT FINAL REMEDIAL ACTION SITE CLOSURE REPORT OPERABLE UNIT 3, INSTALLATION RESTORATION SITE 2A 14 AREA GREASE DISPOSAL PIT MARINE CORPS BASE CAMP PENDLETON, CALIFORNIA

Environmental Remedial Action Contract No. N62474-98-D-2076 Contract Task Order 0080

Document Control Number 6469 Revision 0

August 6, 2003

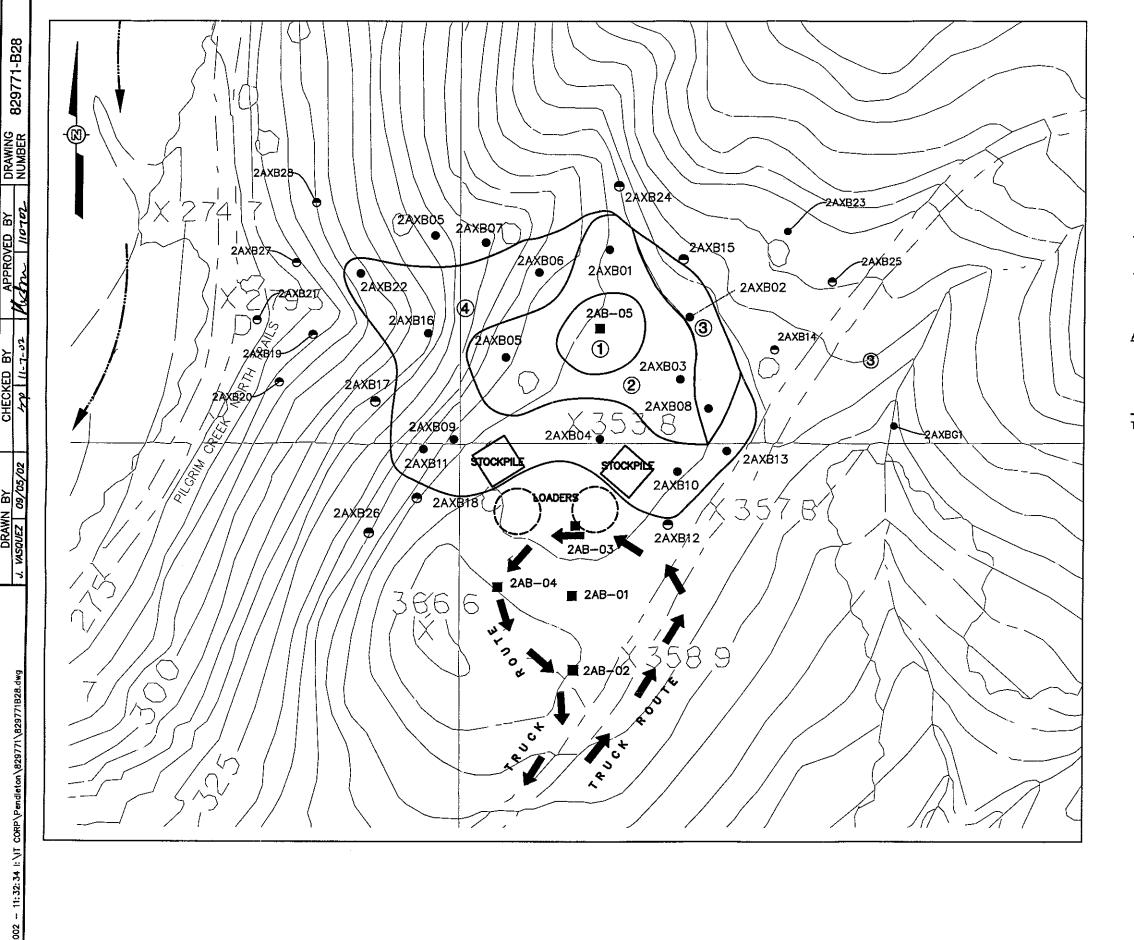
FIGURE 2-2

ESTIMATED EXTENT OF CONTAMINATION IR SITE 2A

The estimated areal extent of contamination was developed based on the new data collected at IR Site 2A in May 1998, as shown in Figure 2-2, along with the boundary presented in the OU-3 RI/FS (SWDIV, 1998a) and the boundary of debris noted in the soil borings

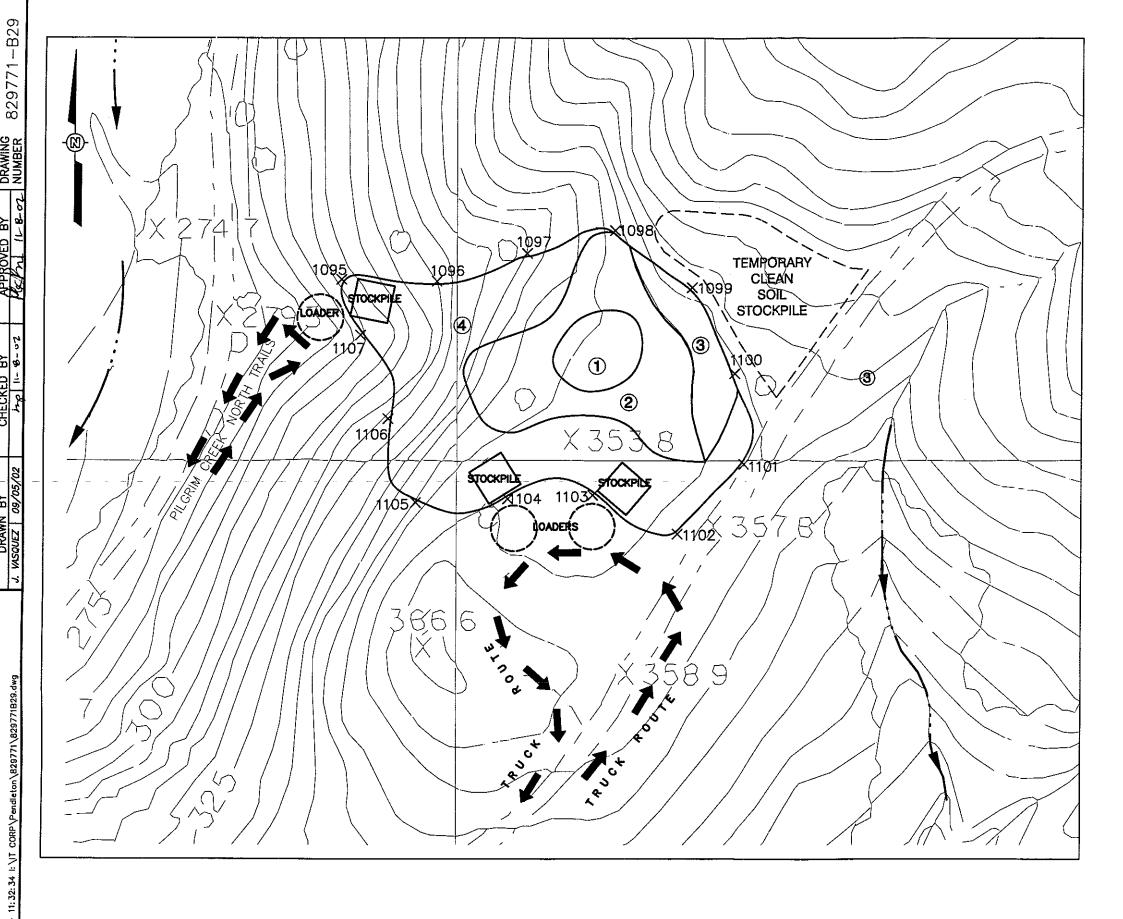
FIGURE 3-1

CONFIRMATION SAMPLING PLAN IR SITE 2A

Inspection of the floor throughout the planned excavation activities revealed ash-like soil in selected areas. The initial floor confirmation sampling results (Table 3-2) indicated that these areas (mainly along the C and D grid lines in Figure 3-1) exceeded the cleanup standards for the COCs. It was decided based on these results that additional excavations would be conducted to remove all visible burned debris and ash material in order to meet the remedial cleanup goals for the site.

After overexcavation activities were complete, sample results indicated that soil in the vicinity of grid locations B2, B5, C2, C3, C5, and F6 (Figure 3-1) required further removal. Analysis of the 2-foot samples collected from these locations indicated that it would meet the cleanup standards. One additional floor sample was collected from grid location E5 as a result of overexcavation of the discolored oily soil found near the upper loading area (see discussion in Section 3.2.3). The sample collected during the planned excavation stage indicated that the soil above the discolored layer was clean. Therefore, the area was probably covered with clean soil after the disposal activities ceased.

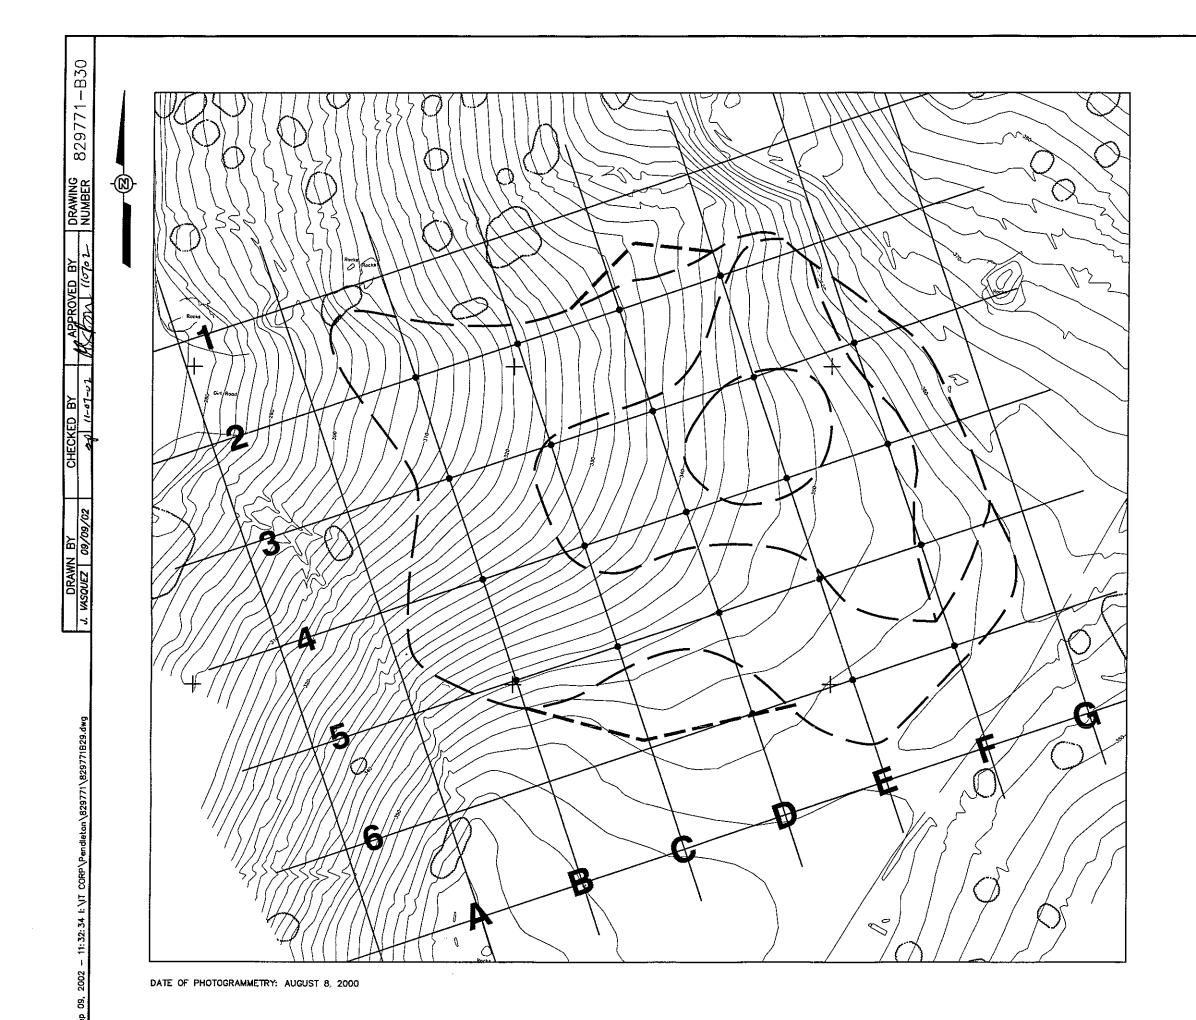
FIGURE 3-2 SITE PLAN AND PLANNED EXCAVATION BOUNDARY IR SITE 2A

The site preparation work was completed on June 29, 1999. The site plan is shown in Figure 3-2. In addition to the above activities, 18 test trenches were dug on June 29 and 30, 1999, at various locations throughout the site to confirm the depth and characteristics of the contaminated soil. Trenching activities revealed that burned debris exceeded the PEDs in the west-central portion of the excavation area. It was decided that the confirmation samples collected from the excavation floor at the planned depth would determine whether additional removal action was required in that area.

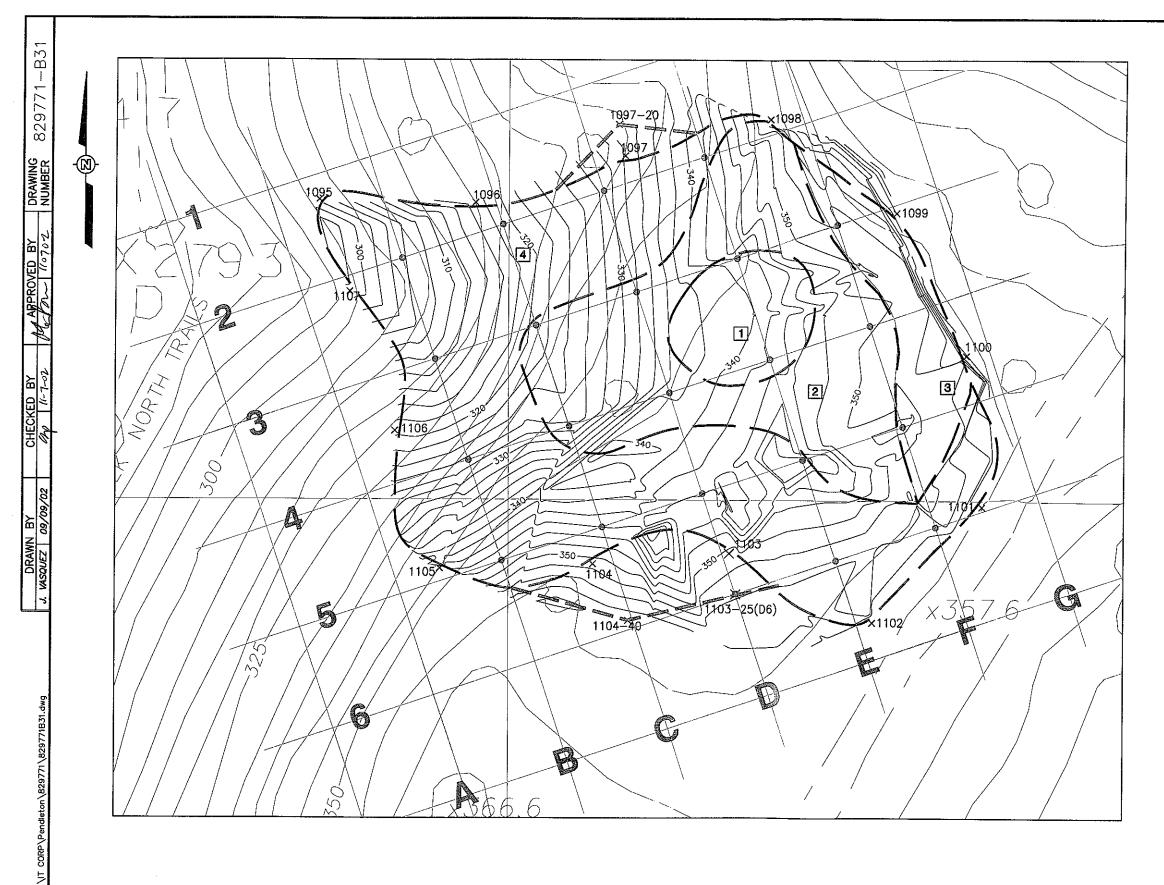
FIGURE 3-3

FINAL SITE GRADE AS-BUILT CONDITIONS IR SITE 2A

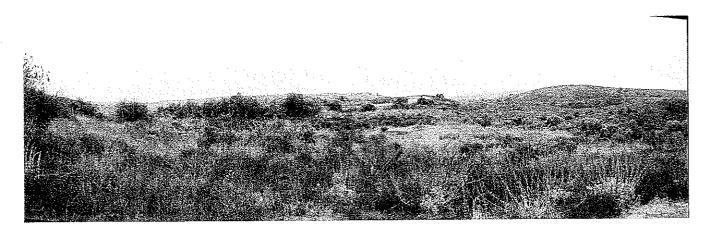
Photograph No. 1: Site 2A Before Soil Removal Activities (June 28, 1999)
Photo Control Location (PCL) #3

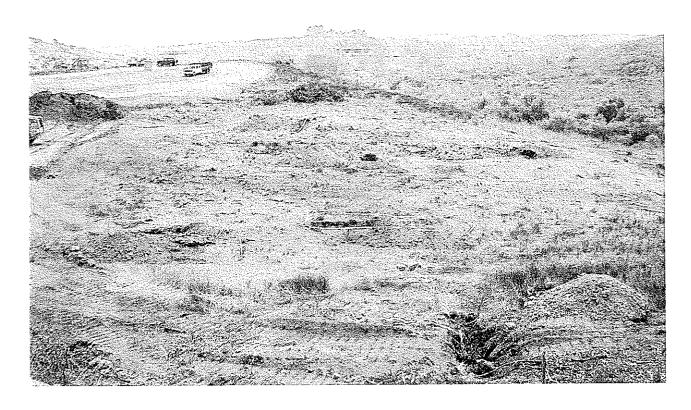
Photograph No. 2: Trenching Prior to Excavation Activities (June 29, 1999) PCL #3

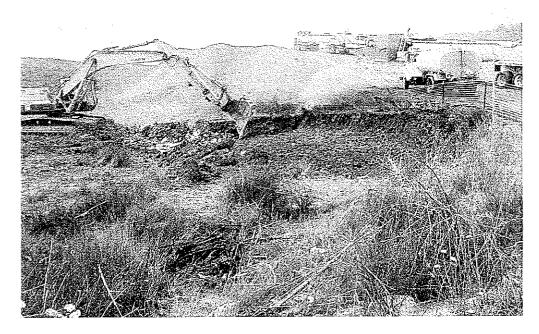
Photograph No. 3: Second Day of Excavation and Stockpiling Activities (July 7, 1999) PCL #2

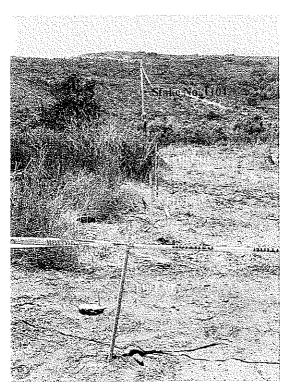
Photograph No. 4: Perimeter Stake Location No. 1104, Stepped out 10, 20 and 30 feet (July 6, 1999)

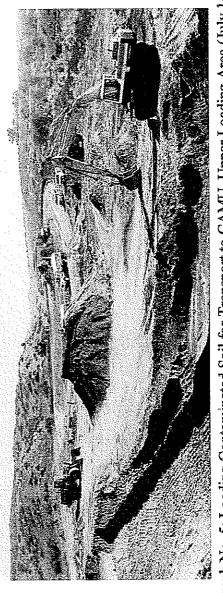
Photograph No. 5: Loading Contaminated Soil for Transport to CAMU, Upper Loading Area (July 14, 1999) PCL #3

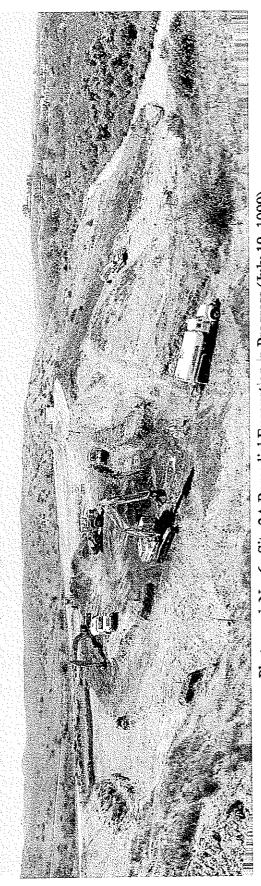
Photograph No. 6: Site 2A Remedial Excavation in Progress (July 19, 1999) PCL #3

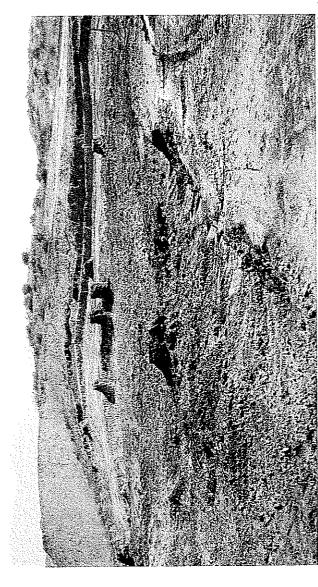
Photograph No. 7: Ash Debris at Planned Excavation Depths, Unexcavated soil monuments used for depth control in background (July 22, 1999)

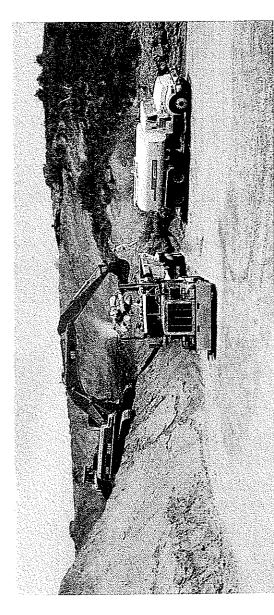
Photograph No. 8: Loading Contaminated Soil for Transport to CAMU, Lower Loading Area, west side of site (July 28, 1999)

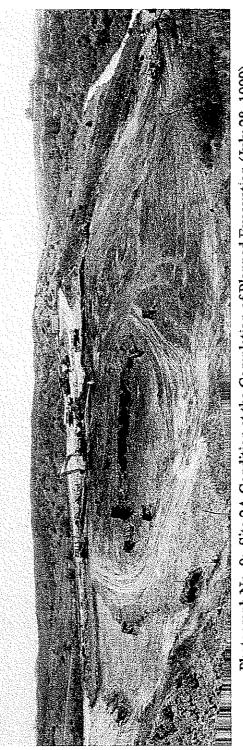
Photograph No. 9: Site 2A Condition at the Completion of Planned Excavation (July 28, 1999)
PCL #3

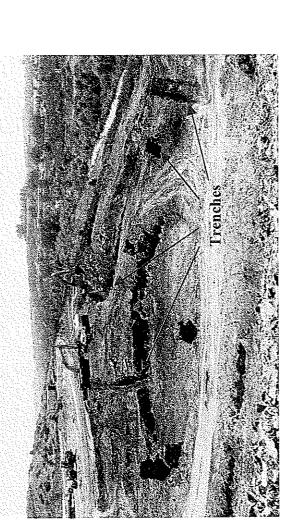
Photograph No. 10: Trenching Prior to Over-Excavation Activities (August 2, 1999) PCL #3

Between July 30 and August 2, 1999, prior to any additional overexcavation, additional test trenching was conducted in the debris area to verify the depth of the remaining debris layer. Trenching revealed large concrete debris near grid locations C3 and D4 that were not identified in the pre-excavation trenching. The concrete debris was buried in a trench that extended 8 to 10 feet below the PED. Besides the concrete debris, the characteristics of the burn ash and debris were consistent with the debris encountered during the planned excavation.

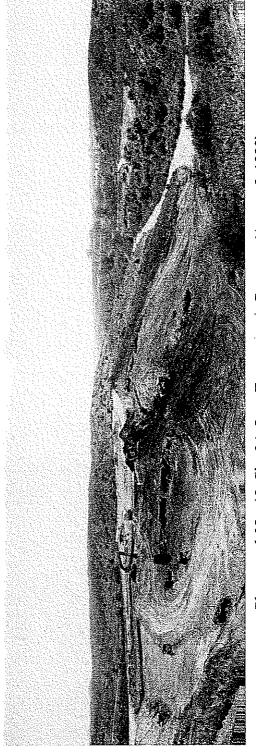
Photograph No. 12: Site 2A Over-Excavation in Progress (August 5, 1999) PCL #3

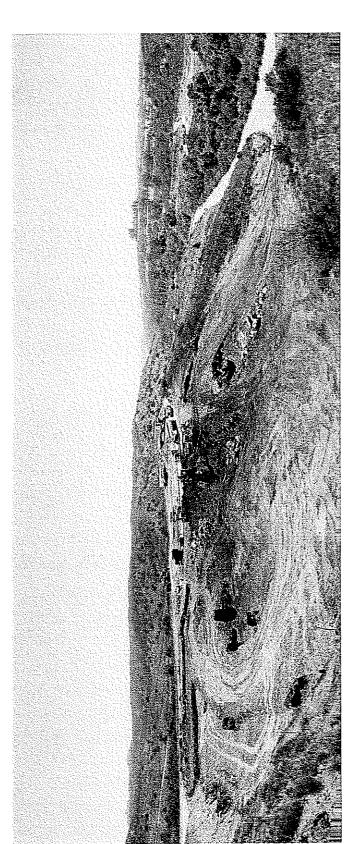
Photograph No. 13: Site 2A Over-Excavation in Progress, Large Concrete Debris near Grid Point C3 Revealed (August 19, 1999)

About 400 cubic yards of concrete debris were excavated out during this stage. About 250 cubic yards of these were transported to the CAMU at IR Site 7 for final disposal. The rest were stockpiled near grid point C3 area. The majority of the remaining concrete debris was very large pieces that appeared to be foundation slabs. It was decided that, because the concrete debris had no burn marks or discoloring on the surface, the concrete debris was not related to the soil contamination at this site and would not pose risks to human health or the environment. Based on this conclusion, the concrete debris was not removed from the site and was used to backfill some of the deeper excavation for erosion control (see photograph in Appendix B). Table 3-3 summarizes the floor confirmation sampling results at the end of this stage. Interim data from sampling locations that were subsequently overexcavated are not included in this report.

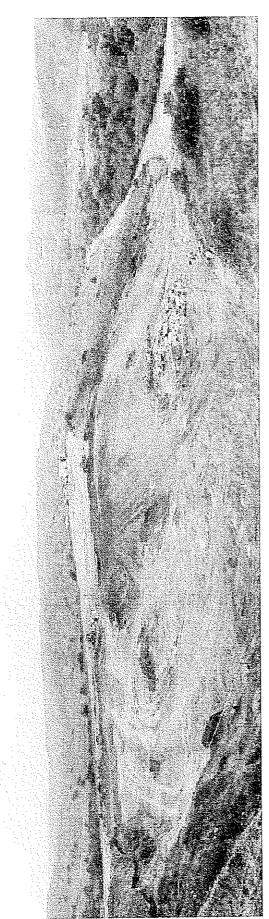
Photograph No. 15: Site 2A Condition at the Completion of Overexcavation (September 24,1999) PCL #3

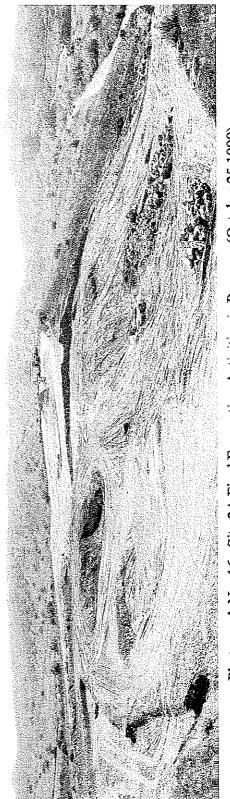
Photograph No. 16: Site 2A Final Excavation Activities in Progress (October 25,1999) PCL #3

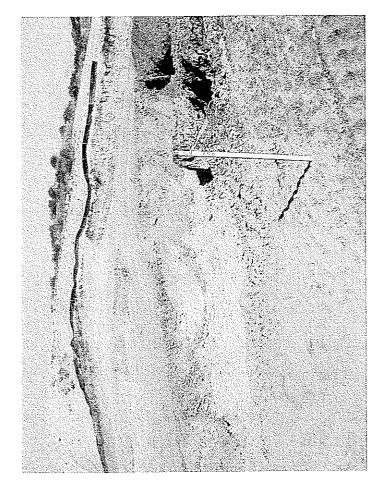
Photograph No. 17: Pockets of Contaminated Material near Grid Point D6 Found During Final Excavation (November 3,1999)

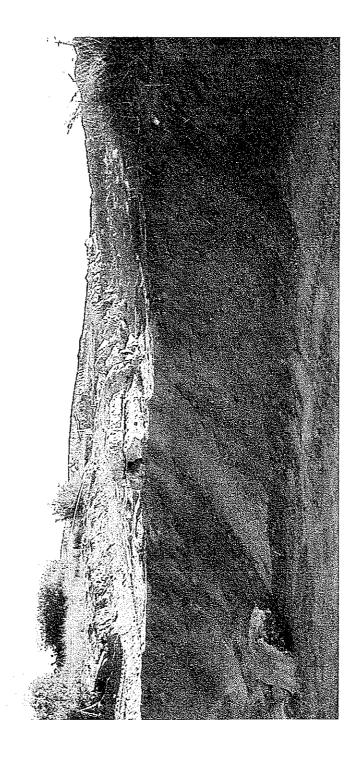
Photograph No. 19: Excavated Concrete as Rip-Rap for Winterization (November 23,1999) PCL #4

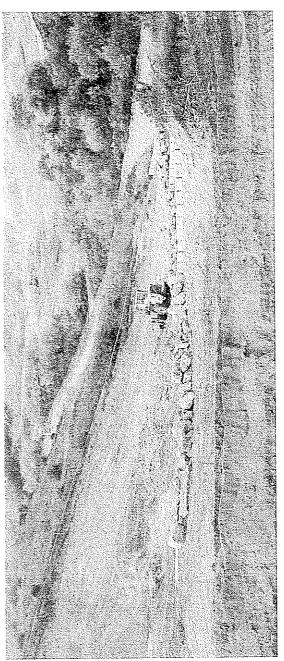
Photograph No. 20: Winterization (November 30,1999) PCL #3

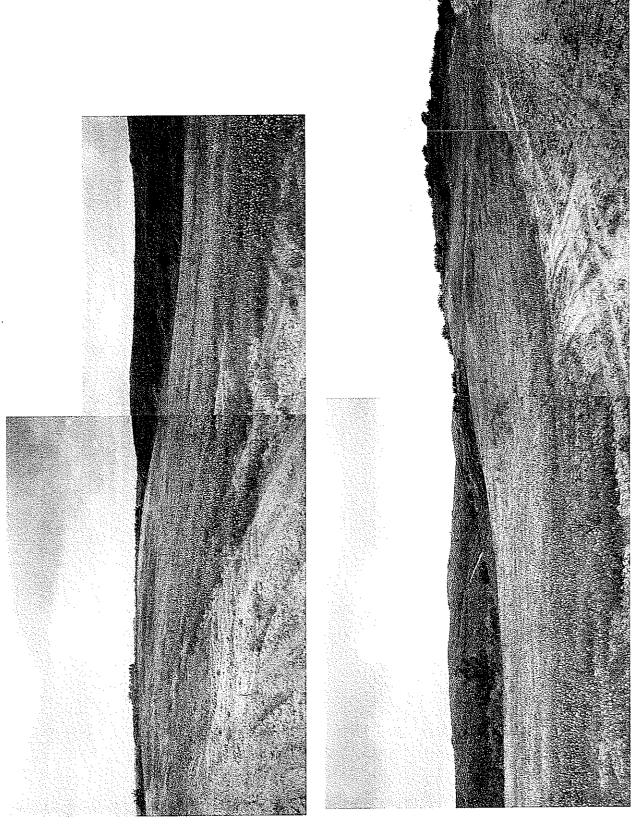
Site Grade Restored and Revegetated (April 11, 2001) PCL #2

The final site restoration was conducted between June 26 and July 14, 2000. A volume of about 18,500 cubic yards of clean soil was imported from a borrow site located in 22 Area of the base (Figure 1-2) and was used as backfill to restore the surface grade. The site drainage pattern was also restored to preexcavation conditions. Because the majority of the site was on slopes, the imported soil was compacted in 1-foot lifts to a minimum of 90 percent of the maximum dry density as determined by American Society for Testing and Materials (ASTM) D 1557 method. A geotechnical subcontractor performed field method QC activities to verify that the backfill was properly compacted and graded in accordance with the final site restoration plan. The subcontractor's field QC report is presented in Appendix C. The final site grade is shown in the as-built topography map presented in Figure 3-3. During October 2000, the site was seeded with a mix of native plants that was approved by the base biologist and the U.S. Natural Resources Conservation Service. The seed mix specification is presented in Appendix D.

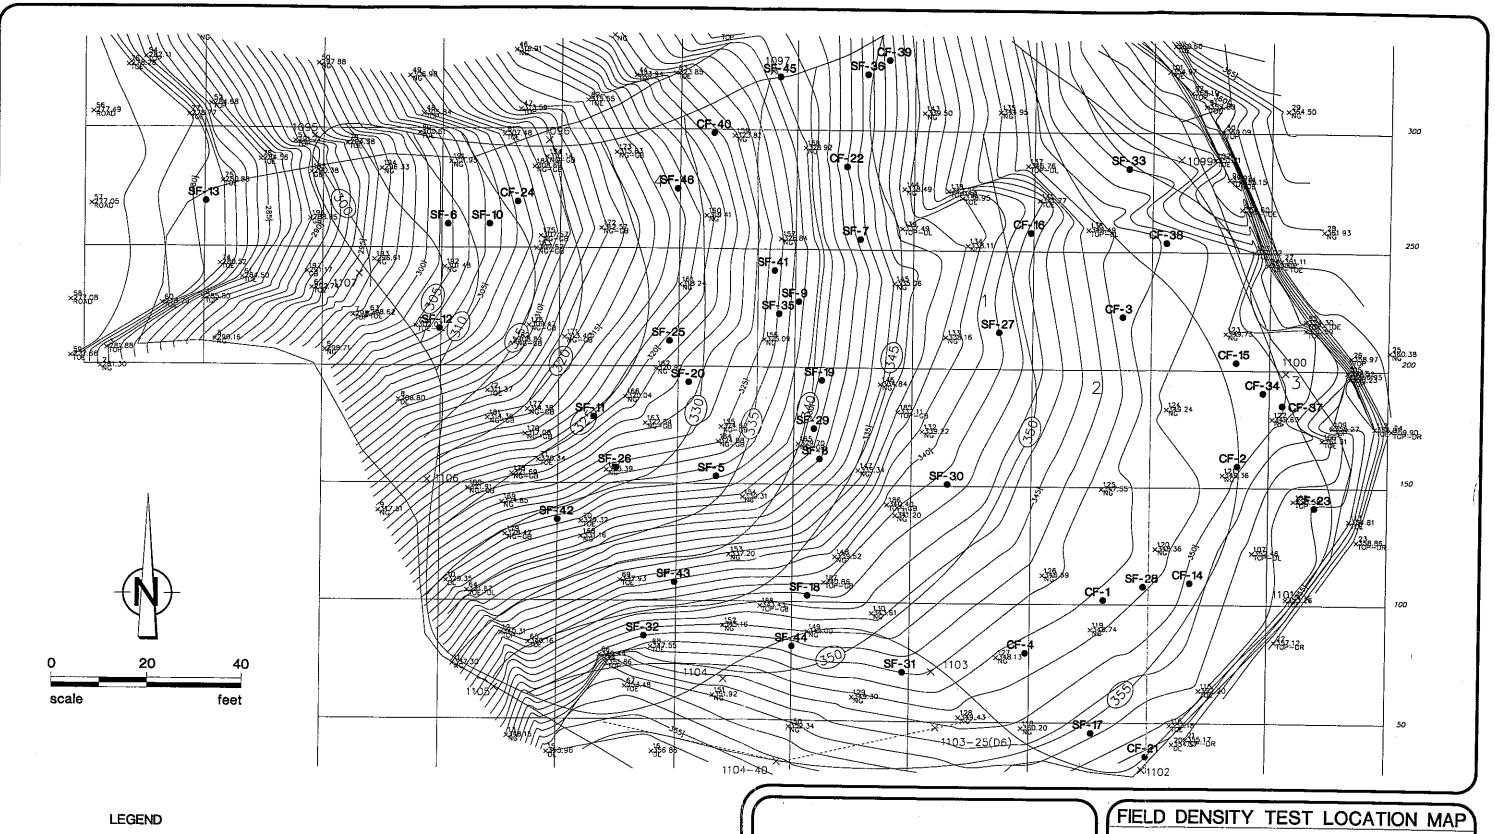
• **CF-39** Approximate location of slope face

• SF-46 Approximate location of compacted fill

In-place density and moisture content testing was performed by our field representative in accordance with ASTM D2922-91 and D3017-88 (Nuclear Gauge Method) The summary results of field density tests are presented in Table 1 The approximate test locations of compacted fill material are plotted in Figure 1.
